# Archaeological Damage Assessment in Conflict Zones: Integrating Satellite Imagery and Ground Surveys in Daraa, Syria

**Keywords:** archaeology | conflict zone | damage estimation | Daraa | ground survey | local communities | satellite imagery | Syria

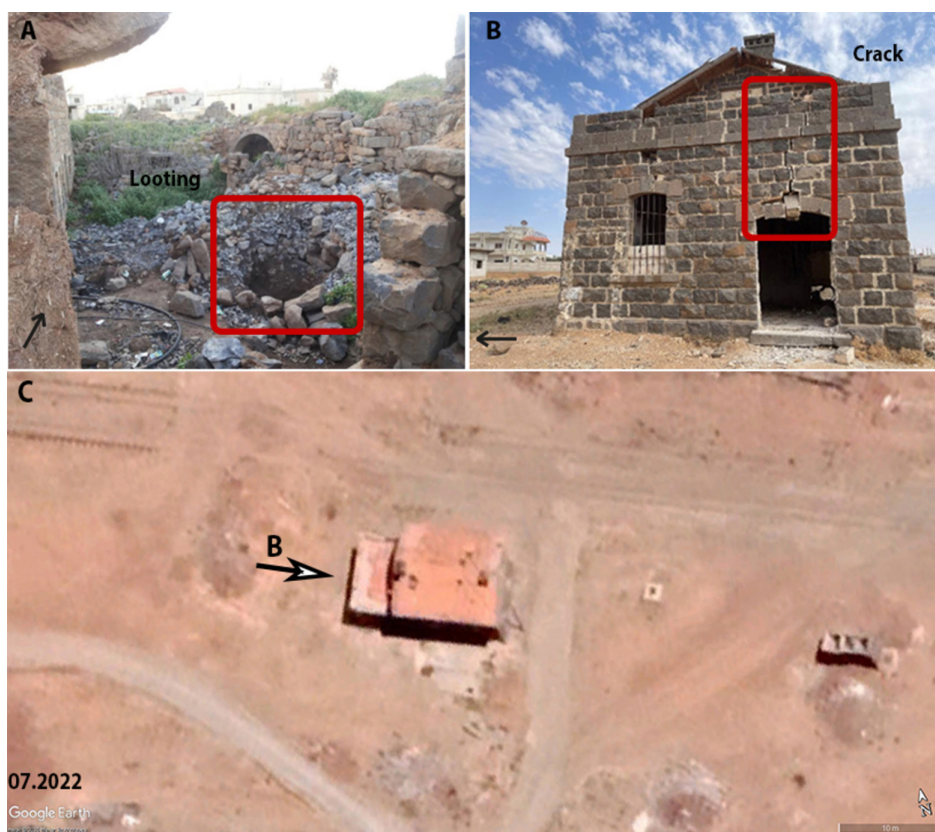
**FIGURE 5** | (A) Evidence of explosive use in looting at the ancient town of Saida Village, documented during a 2015 field visit (Al Kassem 2016). This mechanism of looting was not detected using satellite imagery, and only visible in field visits. (B) Cracks in the walls, looting of the doors and ceilings, and felling of the trees in the periphery of the Al Teibeh station. Again, none of these damages were clearly visible in satellite imagery, as can be seen in the train station of Al Teibeh in (C) (Image 2025 Maxar Technologies. Used in accordance with the Google Maps/Earth terms of service for research purposes).

Overall, the field assessment suggests not only that the quantity of looting pits is greater than the number located through the satellite assessment but also that it much more accurately provides us with the mechanism of damage. The field survey also evidenced what is likely repeated looting through time, evidenced by faint depressions, which are not clear on satellite images. These depressions are sometimes pits that have naturally filled in over time, while looting (by hand) and bulldozing are common. Some sites, such as Al-Salytee, Al Mintar, Khirbet Al Jeezah, Khirbet Hamas, Khirbet Souhoob, Khirbet Gasoum, Khirbet Al Qnaia and Khirbet Tabeel, also show evidence of looting with explosives (Figures 5A and 8D).

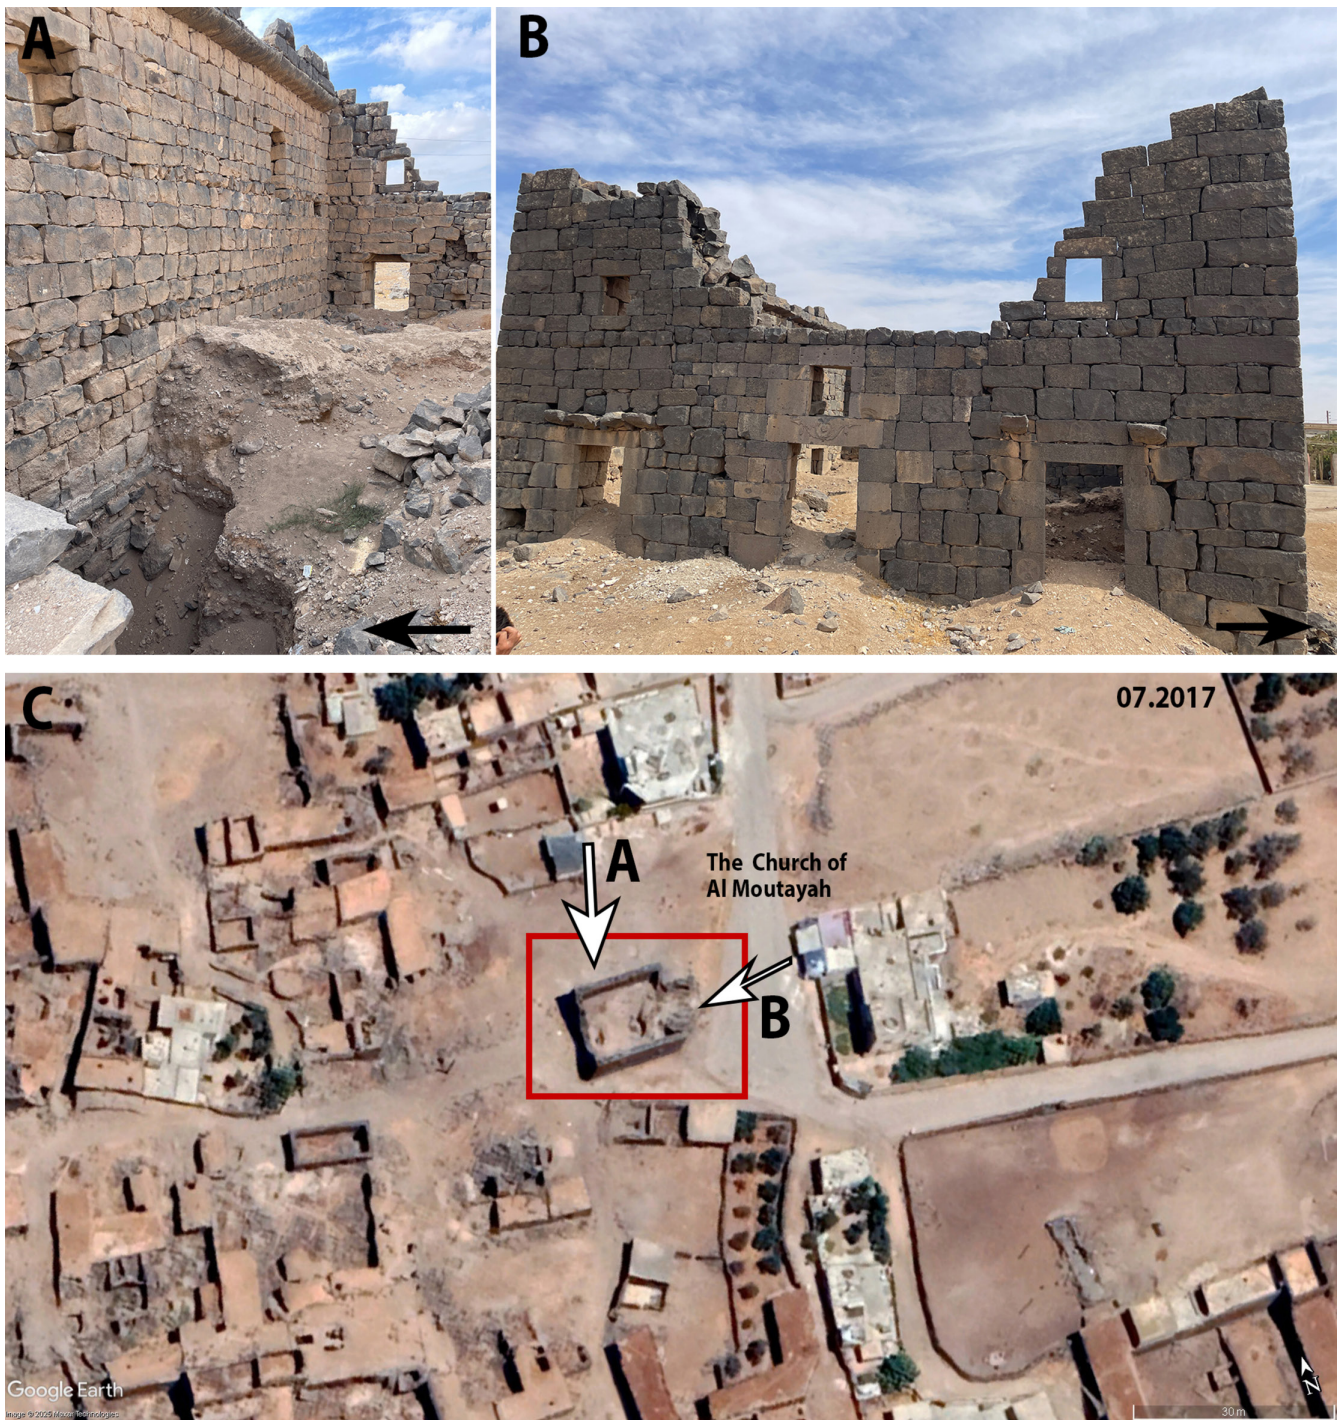
**FIGURE 6** | (A and B) Looting pits documented in the church of Al Moutayah, extending beyond 2 m in depth, increase the likelihood of the wall collapsing in the future. The severity of this damage cannot be accurately assessed using satellite imagery alone, highlighting a key limitation of this method. (C) The church of Al Moutayah on satellite imagery in 07.2017 (Image 2025 Maxar Technologies. Used in accordance with the Google Maps/Earth terms of service for research purposes).

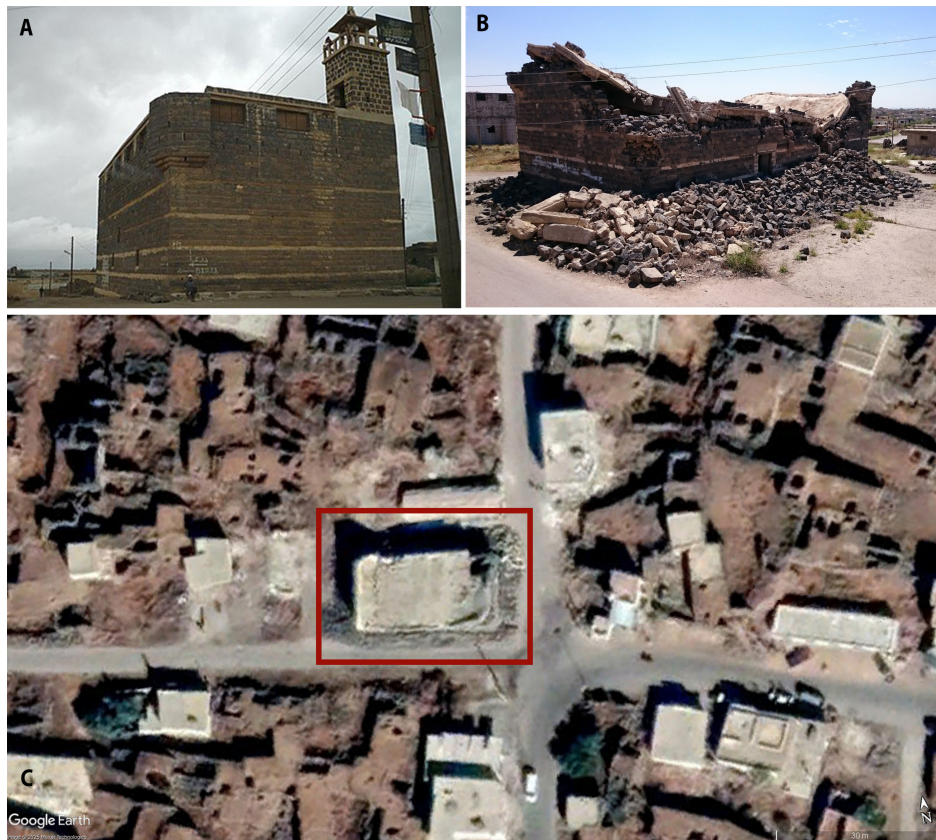
**FIGURE 13** | (A) Al Omary Mosque in Ma'araba before sustaining damage, originally consisting of two floors. (B) The mosque after experiencing structural collapse during armed clashes in 2014, as documented during field visit in 2015. (C) Satellite imagery taken in 2019 shows the location of the mosque (Image 2025 Maxar Technologies. Used in accordance with the Google Maps/Earth terms of service for research purposes). This type of architectural deterioration is challenging to detect using satellite imagery alone, emphasizing the importance of ground-based assessments.

Lastly, satellite imagery is limited in its perspective (i.e., vertical), which restricts the ability to identify certain structural damage such as vertical collapse, internal damage or subtle structural weaknesses such as wall deterioration at Al Omary Mosque (Figure 13).
